## **SmartCast®**

## EXTEND THE FOOT 3" BEYOND THE END OF THE TABLE/CHAIR

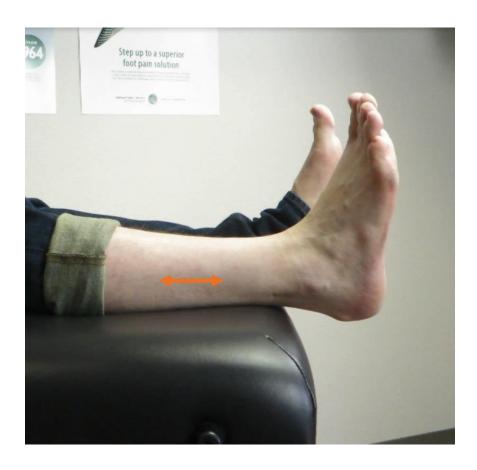
Fully capturing the back of the patient's heel is a crucial part of the scanning process. The iPad/Structure Sensor can only scan what it can "see" with its camera and sensor.

If the foot is extended LESS than 3" beyond the end of the chair, it's impossible to fully capture the heel. A bit more than 3" is okay, although if the foot extends too far, the SmartCast Foot Positioning System® can become unstable and difficult to align.
